Case Study — Helping Alcoa Extend Asset Life

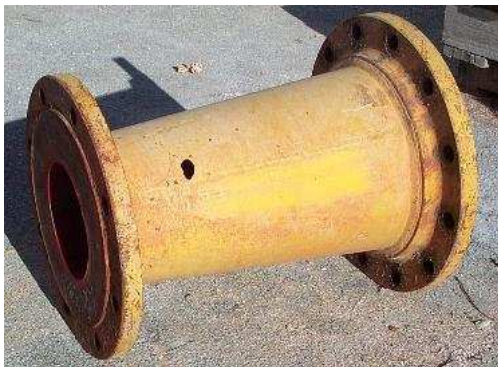
Residue sands transfer is a tough, arduous duty and Alcoa was experiencing severe wear with the polyurethane (PU) lined spools from their Warman pumps. The PU spools were only achieving wear lives of between 5 and 8 weeks. At a cost of AU\$700 per spool, Alcoa was looking for answers to extend the life of these spool pieces to reduce maintenance costs and limit non-productive down time.

Original polyurethane spool lasting 5-8 weeks

Following this consultation a recommendation was made to use Siliconised Silicon Carbide (SiSiC) in this instance as a pipe lining material. It's superior wear rates to other ceramics (Alumina and Basalt) and it's ability to withstand the reduced pH rates in this part of the process made it the ideal ceramic for this application.

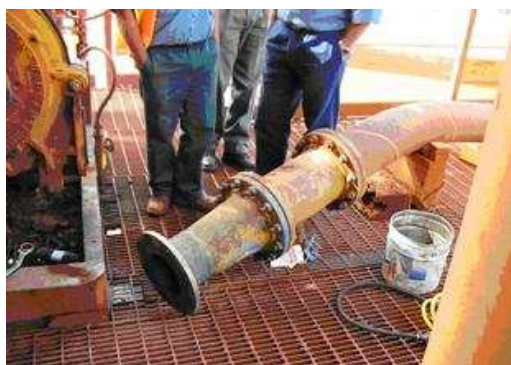
A further inspection was made at 2000 with a small amount of wear visible. The decision was made to return the spool to service and continue until failure occurred.

SiSiC Pipe spool being inspected at 2000 hours and going back into service to complete over 8000 hours

The SiSiC lined spool was installed on 10th February 2003 and inspected after 1200 hours working. There was no noticeable wear visible on the ceramic.

By February 8th 2005 the spool piece had been in service for 8128 hours.

In February 2006 it had been in service for 3 years, this compared to the 5-8 weeks for the previous spool.
